Investigation of strategies to mitigate accelerated deterioration of pig buildings

► Bernardo Predicala, Prairie Swine Centre
Project Status: Completed in 2018

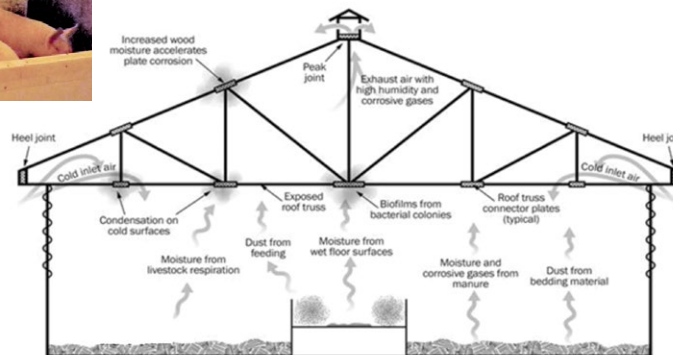
Figure 1. Sources of moisture, corrosive agents and dust that cause corrosion. Adapted from Beadle, 2016. Source: S. Beadle, 2017: "Corrosion of Roof Truss Connector Plates in Farm Buildings." Ontario Ministry of Agriculture, Food and Rural Affairs website

Swine barns are highly susceptible to accelerated deterioration because of varying thermal conditions, presence of dust and decay microorganisms, and high levels of moisture and corrosive gases such as hydrogen sulphide and ammonia especially during the winter months. With this project, researchers wanted to identify potential solutions to mitigate the accelerated deterioration of Canadian swine buildings.

This work also showed that wood structures were degraded by a number of various factors, including the presence of fungi, bacteria, insects, solar radiation, as well as wetting and drying by precipitation, changes in relative humidity and temperature, application of chemicals for cleaning, sanding and power washing. As per metal structural components, the rate of corrosion was accelerated by high humidity levels and the presence of different microorganisms.
